CAR INSPECTION COMPREHENSIVE

Date
Monday, January 4, 2021

Make CADILLAC	Model Escalade LWB	Year 2010
Engine Size 8-Cylinder	Mileage (KM) 224403	Fuel Type Petrol
Regional Specs American	Transmission Automatic	Interior Leather
VIN Number	Number of Keys

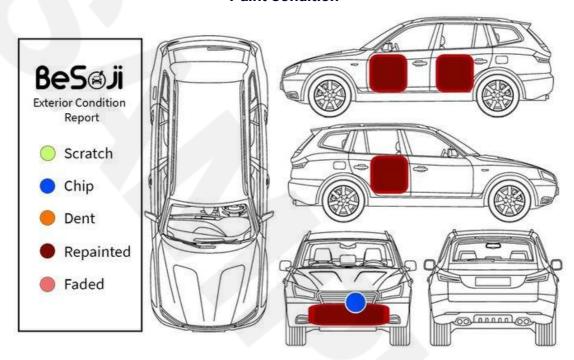
Paint Condition

Exterior: Please refer to the paint condition report. In addition, the rear hook cover is missing, as wellas the rear logo is worn out and the door locks are aftermarket so the doors don't close easily.

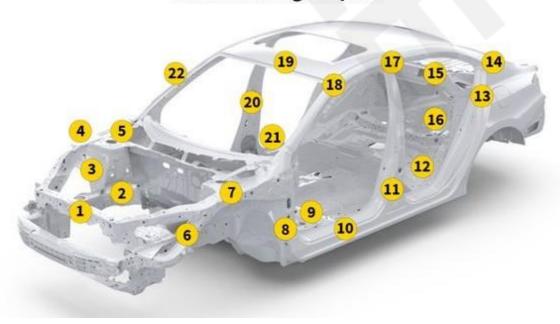
BeSiji Chassis Damage Report

Damage on chassis:

9
