CAR INSPECTION COMPREHENSIVE

Date
Monday, January 4, 2021

Make CADILLAC	Model Escalade LWB	Year 2010
Engine Size 8-Cylinder	Mileage (KM) 224403	Fuel Type Petrol
Regional Specs American	Transmission Automatic	Interior Leather
VIN Number	Number of Keys

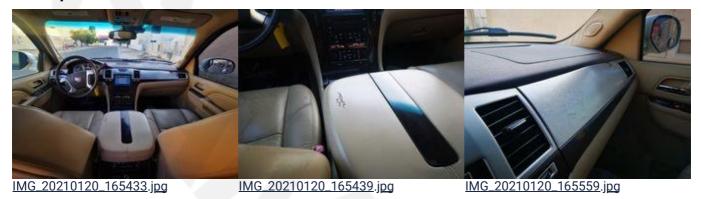
Interior Photos

Interior: The odometer has been rolled back. You can see proof in the interior photos. The driver side door has really bad wiring done. None of the buttons work, as well as the side step sensors are not working. The locks are aftermarket.
